Haywood Road Pedestrian & Bicycle Safety Audit

May 2011

Asheville Bicycle & Pedestrian Task Force

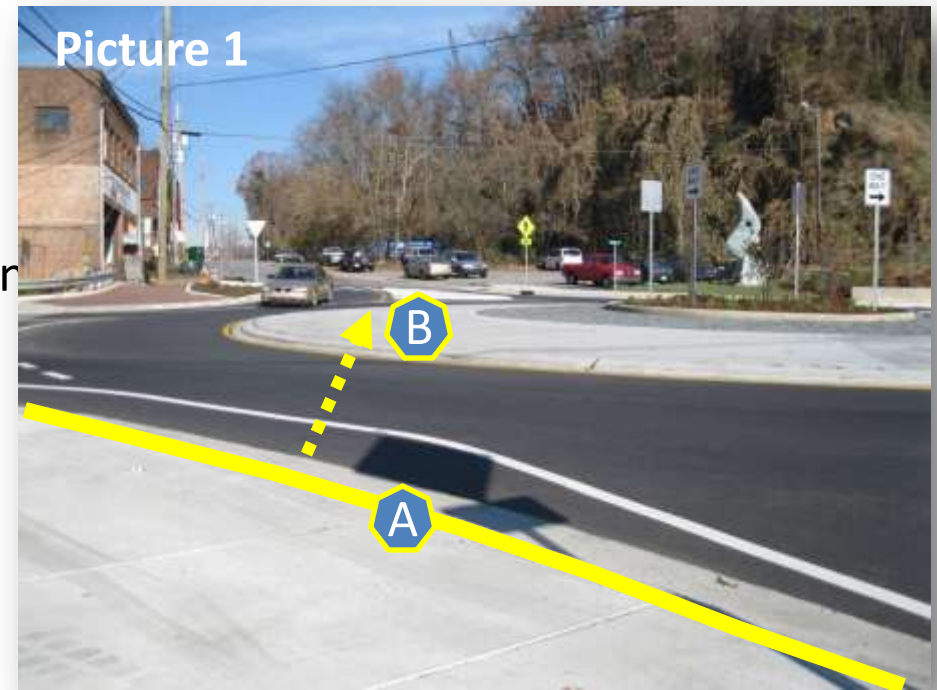
- No raised barrier between sidewalk and roundabout lanes for persons with low vision (*Picture 1*).
- ADA – crosswalk width, median design and curb ramp (*Picture 2*).
- Similar ADA design issues; utility pole in middle of shared ped/bike facility and inadequate clearance width (*Picture 3*).

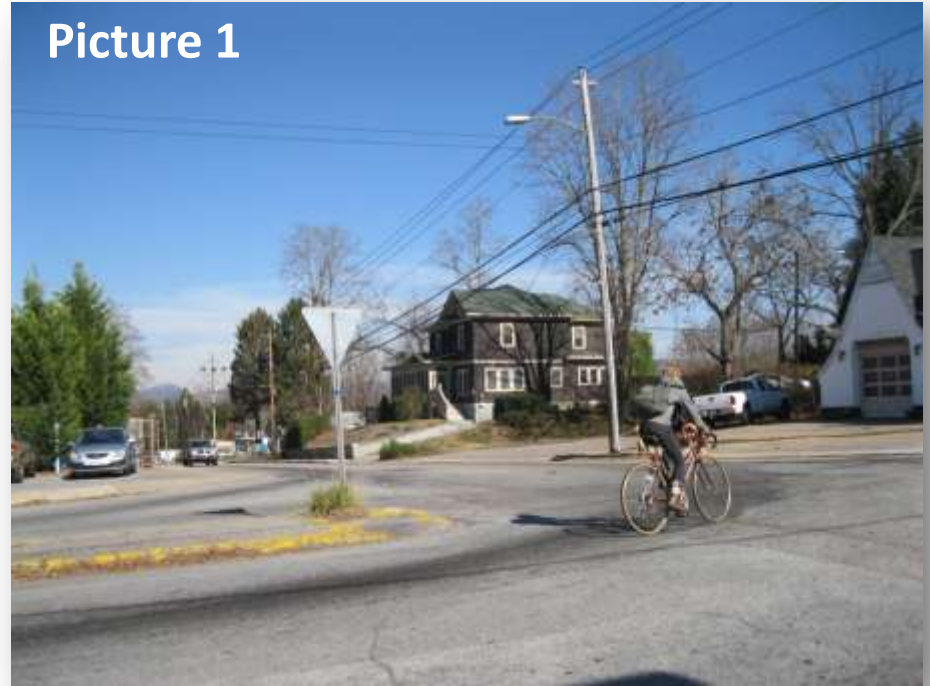
Picture 1

- Confusing intersection for all users (*Picture 1*).
- No crosswalks or signage for safe crossing (*Picture 2*).
- Proposed improvements by NCDOT – no bike lanes/sharrows; little consideration other than cars, such as children walking to school (*Picture 3*).

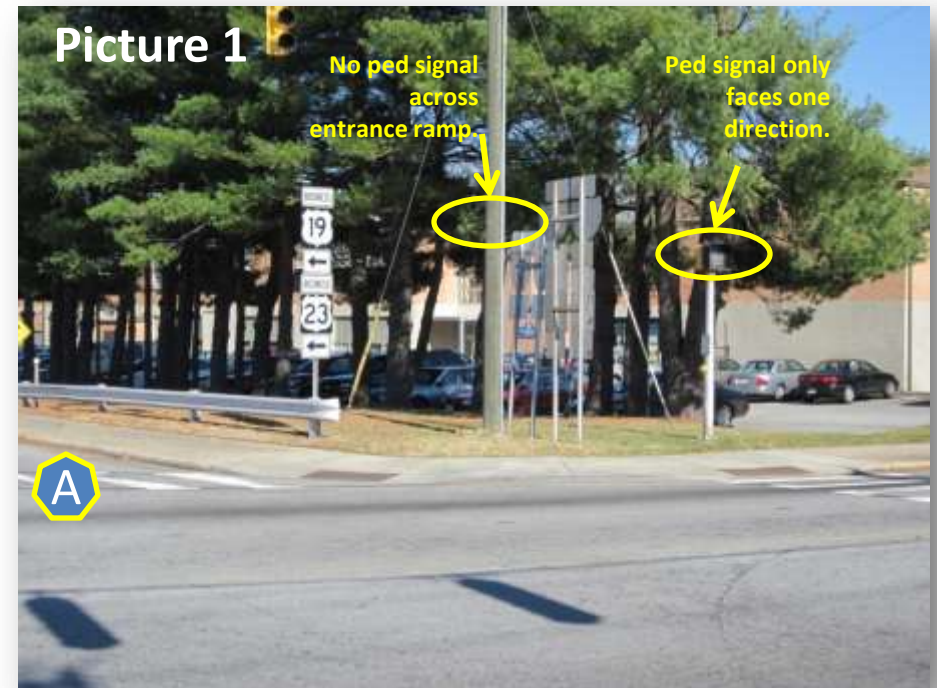
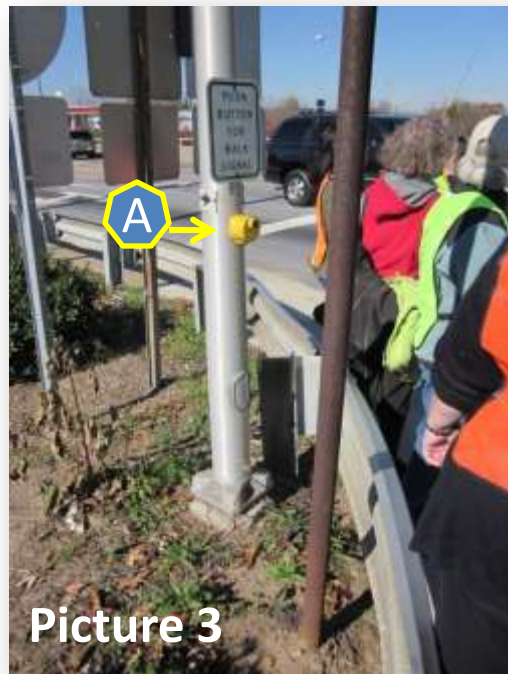
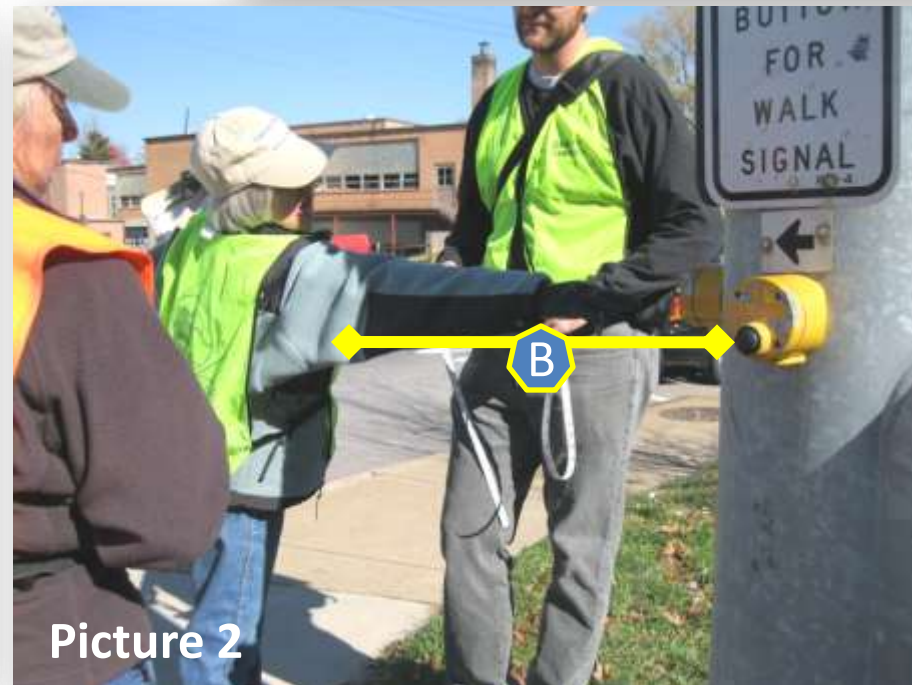
- Confusing for pedestrian due to existing pedestrian facilities.
- Curb ramps and pedestrian buttons not compliant with ADA.
- Pedestrian signals only present on one leg, not on entry to I-240.
- Crosswalks are worn.

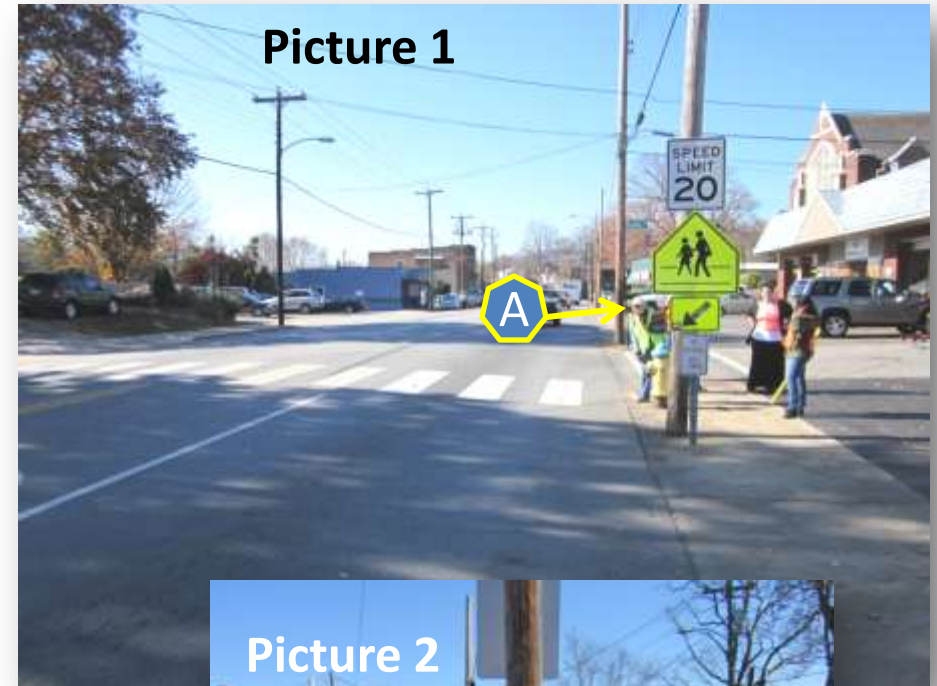
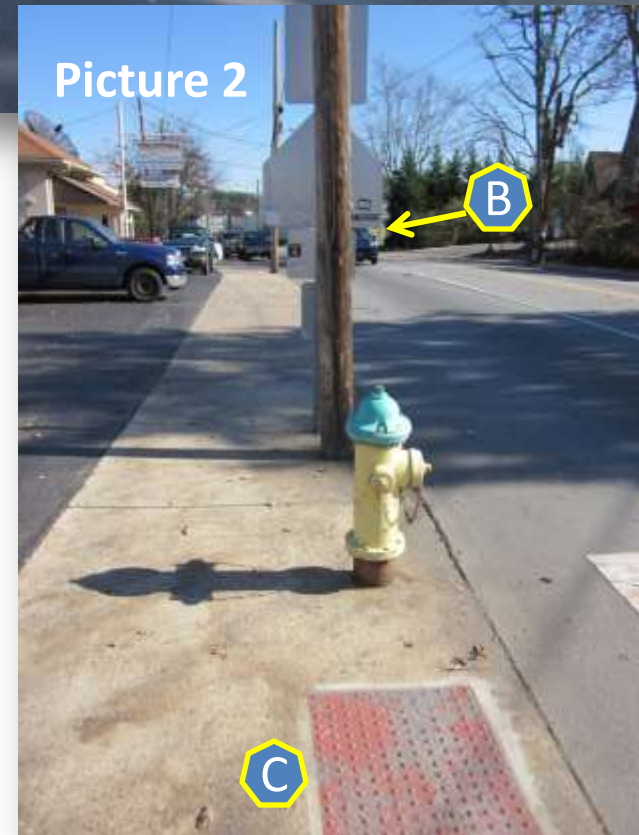
- Mid-block crosswalk placed where pedestrians cannot see motorists and vice versa (*Pictures 1 and 2*).
- Good width on crosswalks and high visibility once pedestrian is in the street (*Picture 3 - A*).
- Non-compliant curb ramp, lacks flat landing area (*Picture 3 - B*).

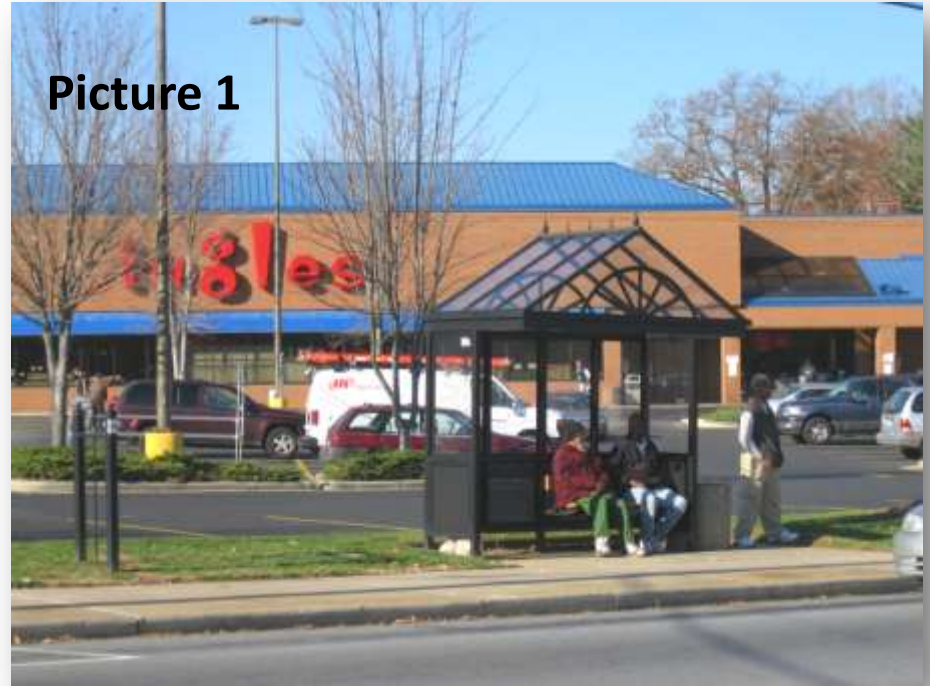
Picture 1

- Transportation hub with high activity.
- No pedestrian signals combined with confusing signal phasing, defective loop detectors.
- No crosswalk to reach south side of Haywood.
- Large unimpeded driveway along south side (*Picture 2*).

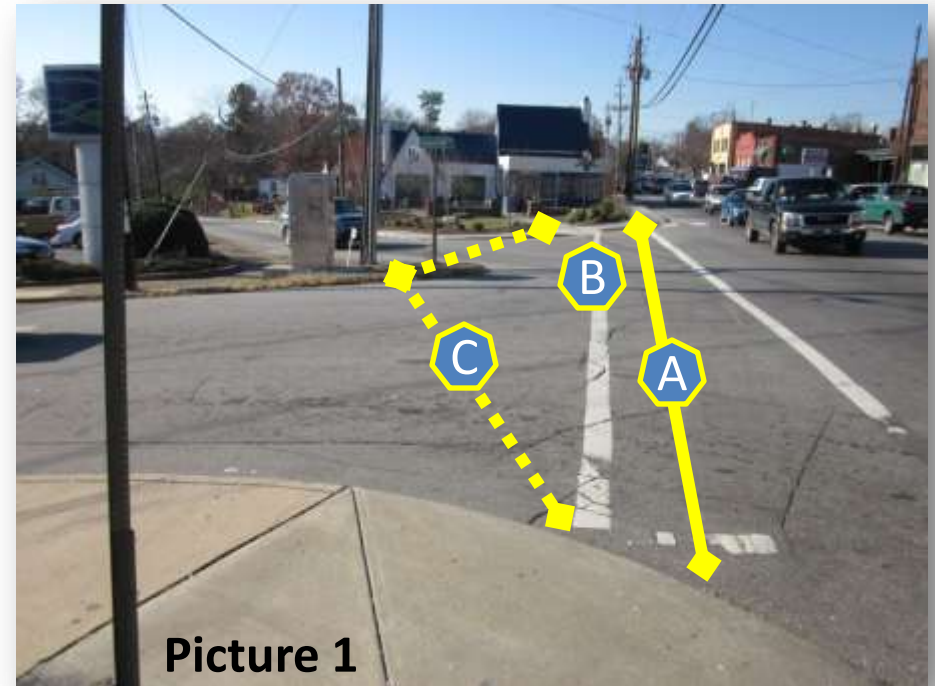
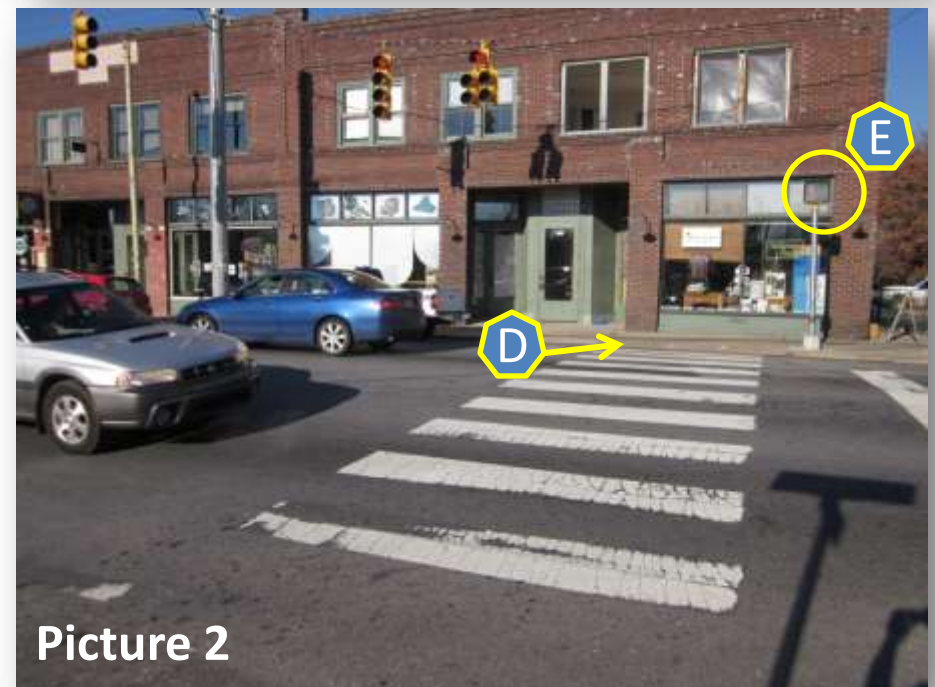
- **Picture 1, A:** Excessive length and confusing alignment for a three-way intersection with split phasing.
- **Picture 1, B:** Potential solutions include installation of refuge area, which would also calm traffic but could present turning radius issues for larger vehicles (although there are limited trucks). Or....
- **Picture 1, C:** Reconfigure crosswalk for staged crossing of the two legs.
- **Picture 2, D:** Receiving ramp does not meet ADA standards.
- **Picture 2, E:** Pedestrian signal placements blends with windows on far-side building. This can create visibility problems for children or person with poor vision.

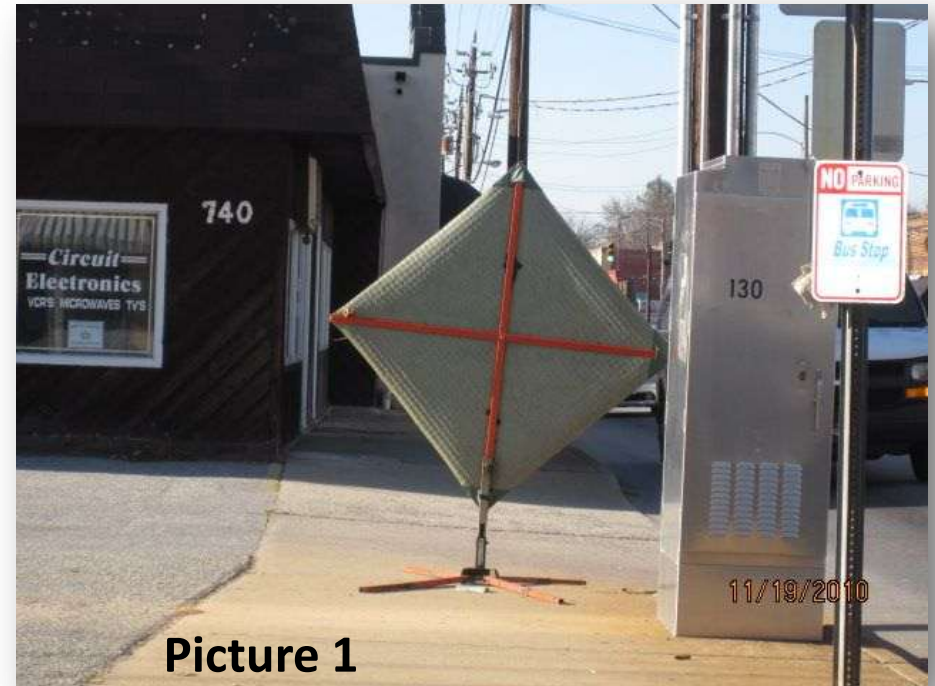
Picture 1

- Placement of temporary traffic signs block pedestrian way (*Picture 1*).
- Vehicles on open driveway cuts parked within pedestrian zone (*Picture 2*).
- The lighting along the entire Haywood Road corridor is considered “highway scale”, not pedestrian scale (*Picture 3*).

- Encourage neighborhood-based initiatives to maintain and clear sidewalks;
- Connect pedestrian facilities to transit stops located along Haywood Road;
- Encourage changes in construction practices that disallow placement of temporary signage in the sidewalk;
- Utilize lessons learned from new roundabout to avoid repeating design flaws.
- Re-stripe Haywood Road to reflect recommendations for bike lanes / sharrows.
- Work with City to encourage new development or re-development to conform to best practices and ADA.

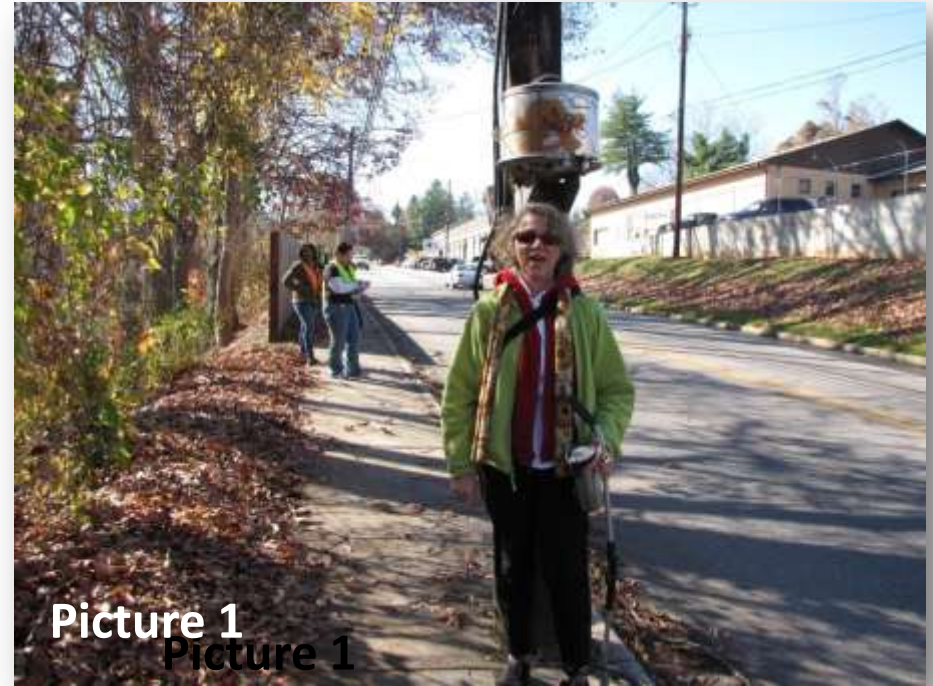
- Utilities on side of pole does not have 7-foot clearance (*Picture 1*).
- Poles in sidewalk do not allow for ADA-required clearances (*Picture 2*).
- Installation of new poles along Brevard Road left debris and restricted the clear width to only 17 inches (*Picture 3*).
